# スペイン国立装飾美術館所蔵山水人物蒔絵筆筥 [ 修理報告 ]

著者	松本 達弥
図書名	在外日本古美術品保存修復協力事業 : 修理報告書 : 絵画 / 工芸品[平成18年度実施事業] : The Cooperative Program for the Conservation of Japanese Art Objects Overseas
開始ページ	183
終了ページ	197
出版年月日	2008-03-31
URL	<a href="http://id.nii.ac.jp/1440/00005512/">http://id.nii.ac.jp/1440/00005512/</a>

山水人物蒔絵箆笥 (スペイン国立装飾美術館)

*Makie Decoration Cabinet with Landscape and Human*  
(Museo Nacional de Artes Decorativas)

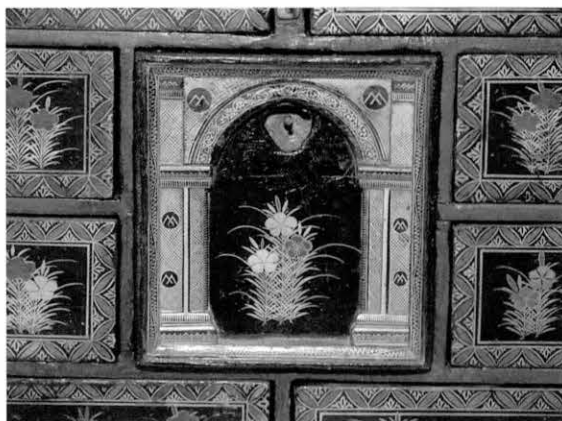
内部、引出の表面は、平蒔絵で紅白の撫子を描く。(図9)

図9 内部引出し 中央部分  
Fig. 9 Drawers inside, middle

Red and white *nadeshiko* flowers are depicted in *hiramakie* on the front face of the drawers within the Cabinet (Fig. 9).

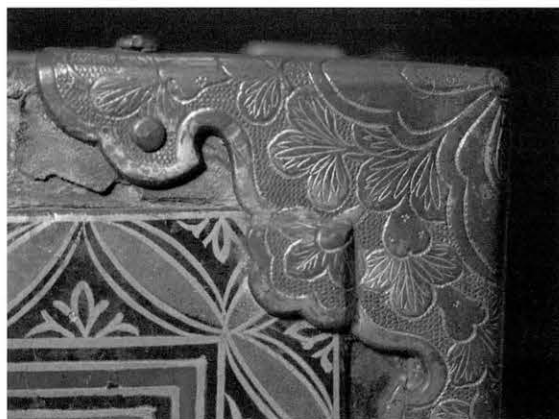
図10 制作当初(日本製)の隅金具  
Fig. 10 Original (Japanese) corner metal fittings

- The front lower right corner metal fitting is a later addition; there were no corner metal fittings on the other three lower corners.
- Much of the coating film at the junction of the top and side panels was missing and the substrate had become exposed. The surrounding coating film had become lifted and there was a great risk of further losses (Fig. 13).

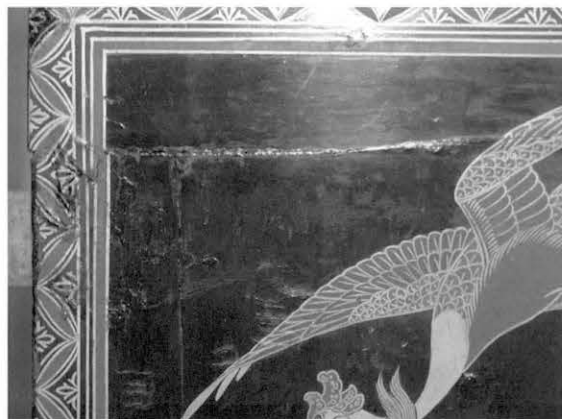
図 34 修復前 扉裏

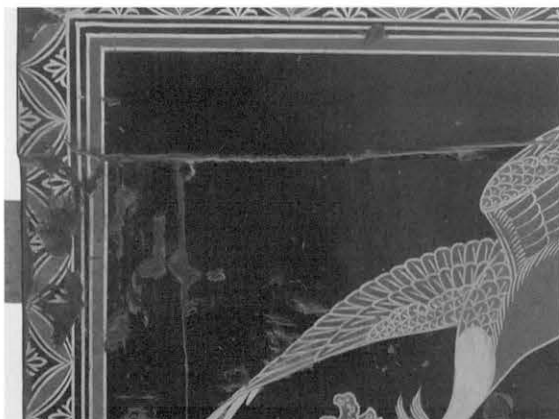
図 35 修復後 扉裏

修復及び技術分析の記録をまとめ、修復後の写真撮影を行い全ての工程を終えた。(図 33 ~ 37)

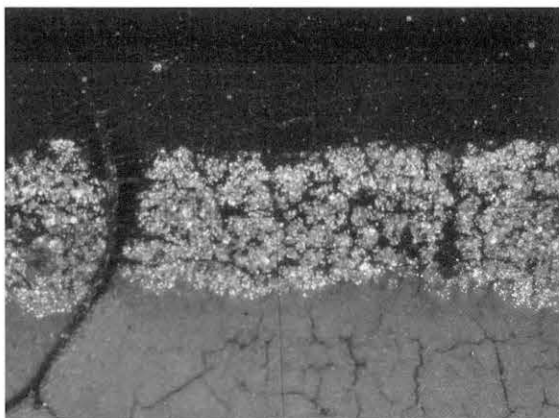
図 37 修復後 表面塗膜の拡大画像 (50 倍)

塗膜表面の艶の復元と修復した部分の固めとして漆固めを行った。漆固めは、木地呂漆と梨子地漆を 3:7 の割合で混ぜ合わせ、溶剤で希釈して行った。漆固めは、各面損傷状態が異なるため、溶剤の希釈濃度を変え 4~6 回行った。なお、高蒔絵部分や螺鈿に余分な漆が残らないよう丁寧に拭き取った。(図 29, 30)
